REPORT DETAILING THE INSTALLATION AND  
OPERATION OF MARINE EXHAUST GAS SCRUBBING  
EQUIPMENT ABOARD THE GREAT LAKES SELF-  
UNLOADING *MOTOR VESSEL LEE A. TREGURTHA*

PREPARED BY  
THE INTERLAKE STEAMSHIP COMPANY  
FOR THE  
U.S. DEPARTMENT OF TRANSPORTATION  
MARITIME ADMINISTRATION

OCTOBER 2018

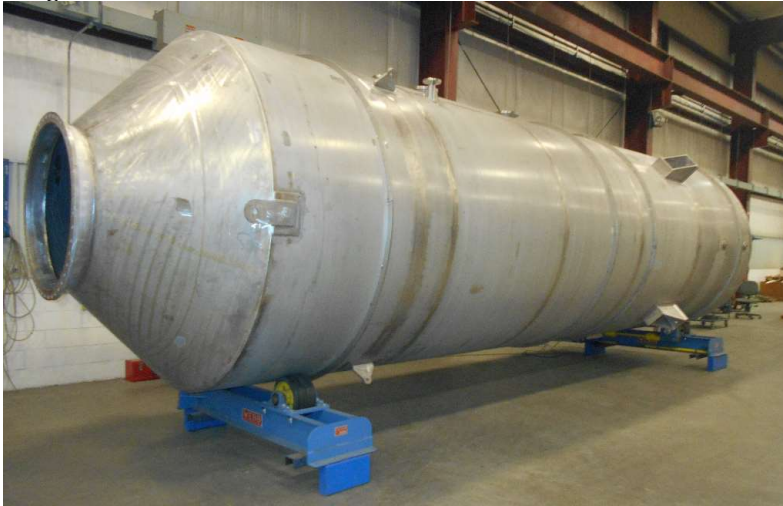
*Image 6*

*Scrubber vessel during fabrication*

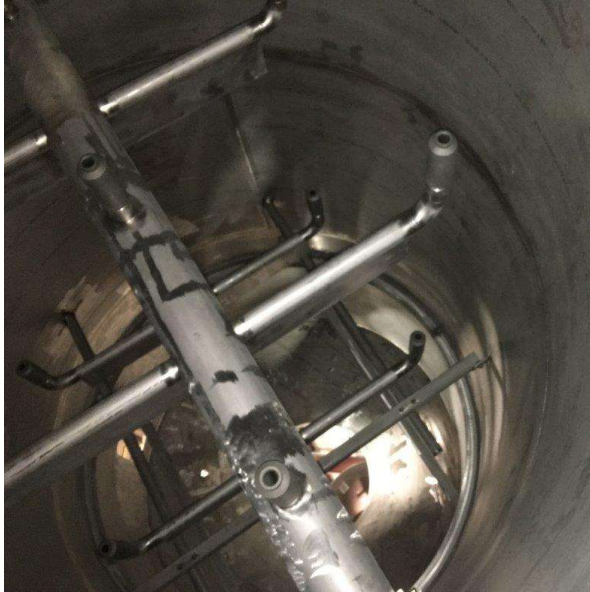
*Image 7*

*A view into the Scrubber vessel during fabrication*

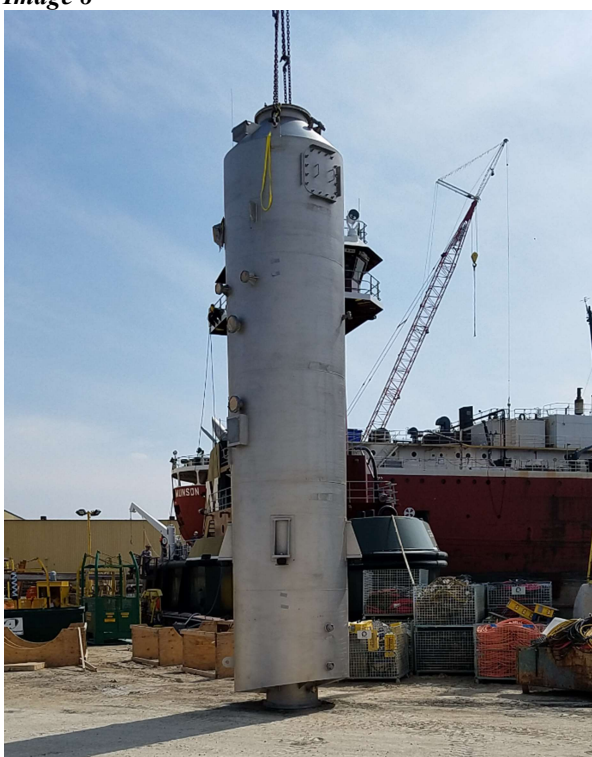
**Image 8**

**Scrubber vessel being lifted for installation**

The BELCO scrubber system was scheduled for installation during the 2015/2016 winter layup period. Prior to the vessel's arrival at the Fincantieri Bay Shipbuilding in Sturgeon Bay, Wisconsin, project equipment was arriving on a regular basis and a great deal of work was being done in anticipation of the *Tregurtha's* arrival. The first of two scrubbers arrived in the shipyard on December 23, 2015 and the second arrived shortly thereafter. Due to an uptick in customer cargo requirements right at the end of the shipping season, the vessel did not arrive at its layup berth at Bay Shipbuilding until January 24, 2016.

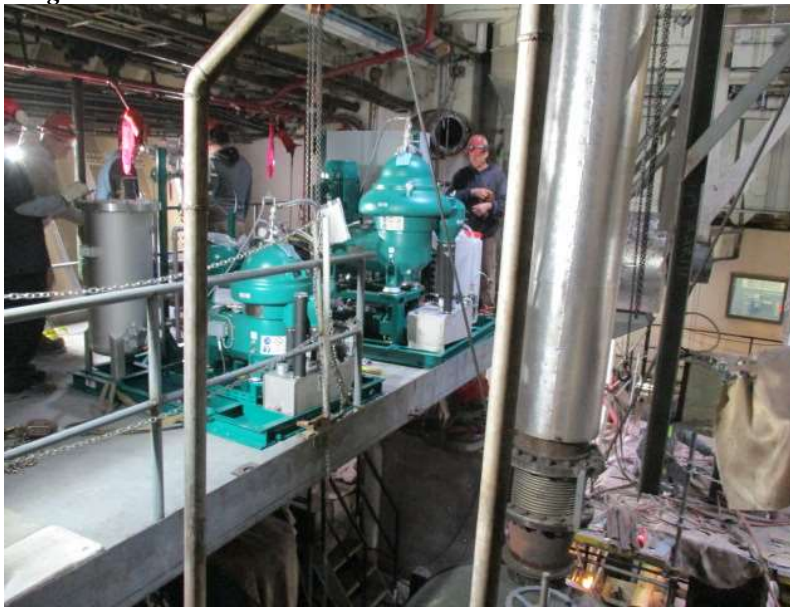
*Image 9*

*Scrubber Master Installed*

The *Tregurtha* project included the installation of a GEA Westfalia Scrubber Master, installed as a peripheral effluent treatment system for the purpose of removing contaminants from the wash water so that it could be discharged overboard. When Interlake first began installing scrubber systems on its vessels, the only available effluent

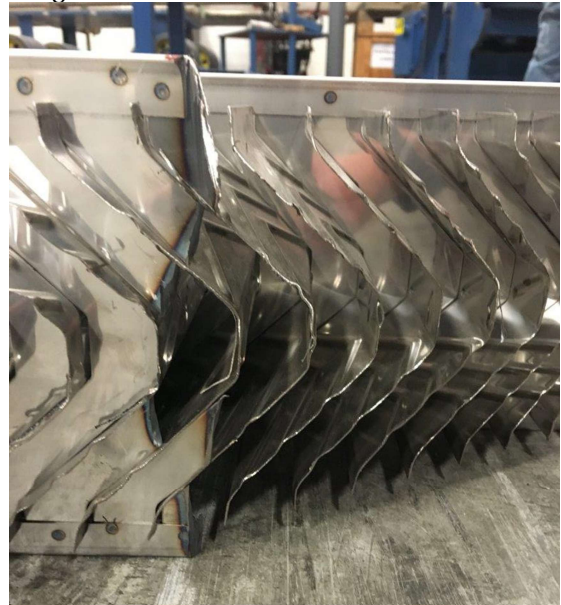
*Image 11*

*Chevron style droplet separators*

Another change in design and specification of equipment between the *Oberstar* project and subsequent scrubber projects including the *Tregurtha* project was a change to the design of the droplet separators in the scrubber vessels. The original droplet separator design

efficiently catching and removing enough moisture from the exhaust as it passed through the system. That resulted in sodium and sulfate residue being carried by moisture in stack emissions, where it immediately precipitated from the stack emissions and settled on the vessel. The change in design to the chevron-style separators, which provided more surface area over which the emissions would pass, was effective at removing that moisture and solving the carry-over issue.

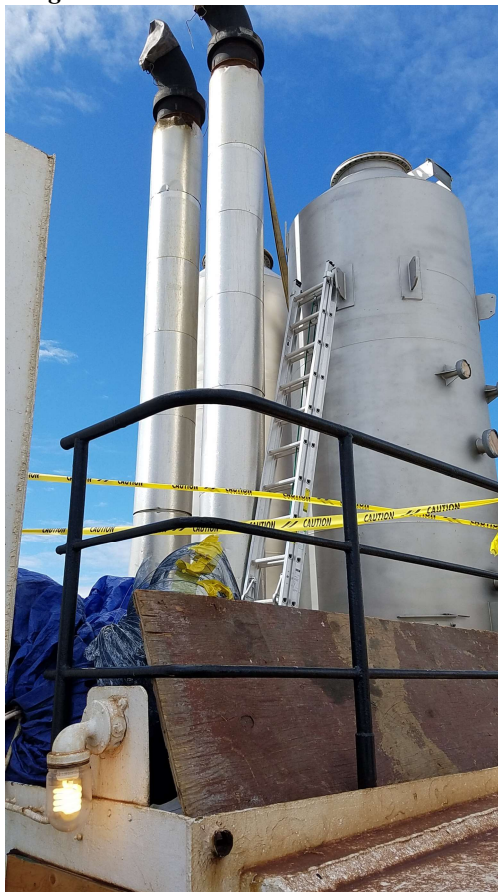
*Image 12*

*Scrubber before stack reinstalled*

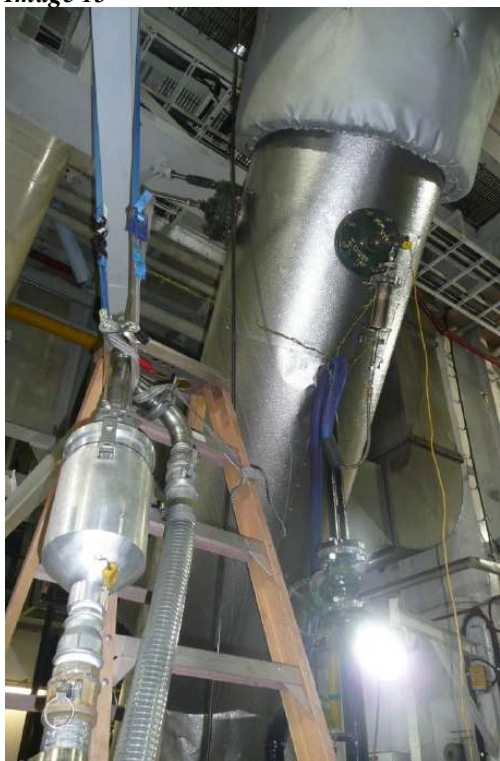
**Image 13**

**Sampling ports before Scrubber**

In order to satisfy the second testing requirement of the Cooperative Agreement with MARAD, Interlake once again secured the services of SGS to conduct the first round of post-scrubber installation emissions testing to verify that the newly installed equipment was functioning properly. Measurements were performed according to Marpol Annex VI. Approximately six weeks after the *Tregurtha's* scrubber system was commissioned, BELCO boarded the vessel on August 12, 2016 to conduct performance testing of both the marine scrubbers.

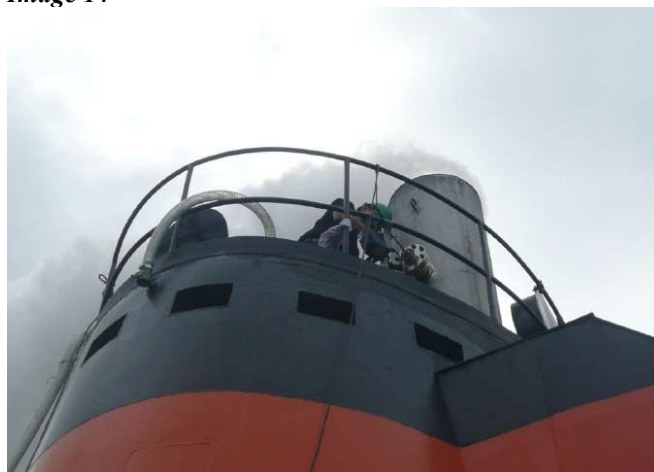
**Image 14**

**Sampling ports after Scrubber**

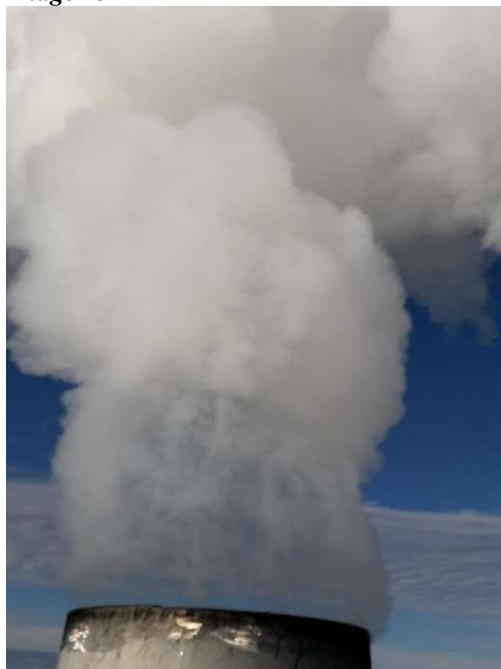
Image 15

Scrubbed exhaust – a plume of steam
